PERFORMANCE AUDIT REPORT

OF THE AUDITOR-GENERAL ON
REGULATING RECLAMATION ACTIVITIES
AT SMALL-SCALE MINING SITES

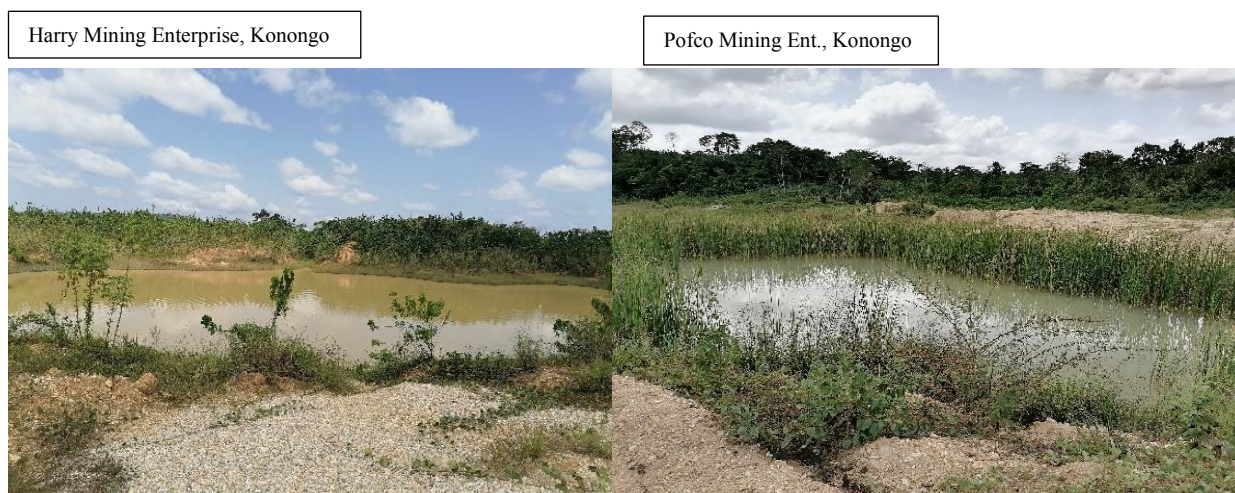
67. EPA's failure to make 12 companies post the reclamation bond, denied them the amount of GH¢524,300.00 which is to be used to reclaim the mined areas in the instance where the proponents failed to do so. We found during our visits to two of the 12 companies whose cost of reclamation was approved by EPA that the operators were no longer working on their concessions and had left mining site without reclaiming them. See Picture 1.

Picture 1: Uncovered mining pits filled with water at abandoned mining sites at

70. We recommend that:

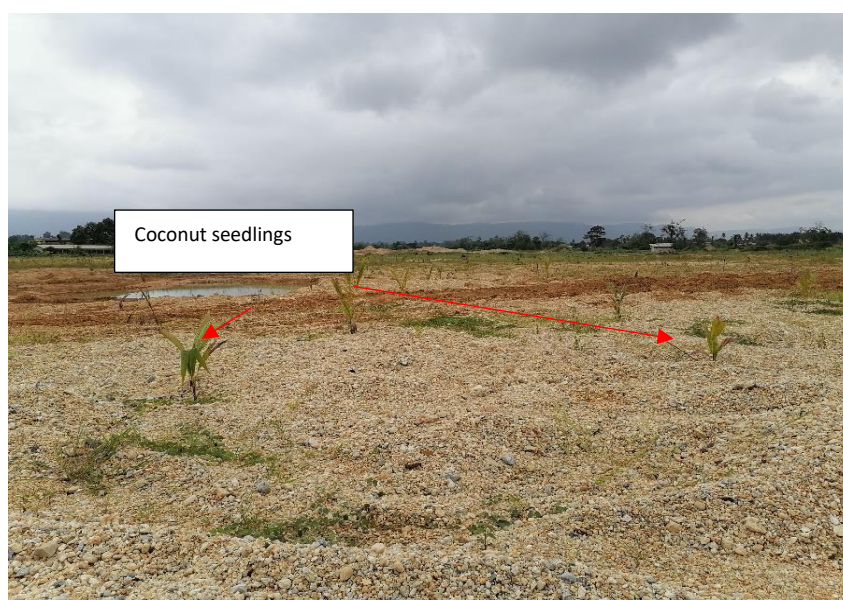
89. On the contrary, reports of Bibiani and Asankrangwa indicated the number of routine visits but was silent on details of specific concessions reclaimed and the extent of reclamation done. We found that Akim Oda was the only District that had a concession with all pits covered, levelled and coconut seedlings planted. See Picture 3.

Picture 3: Acquah Mining Group at Atiwa, Akim Oda

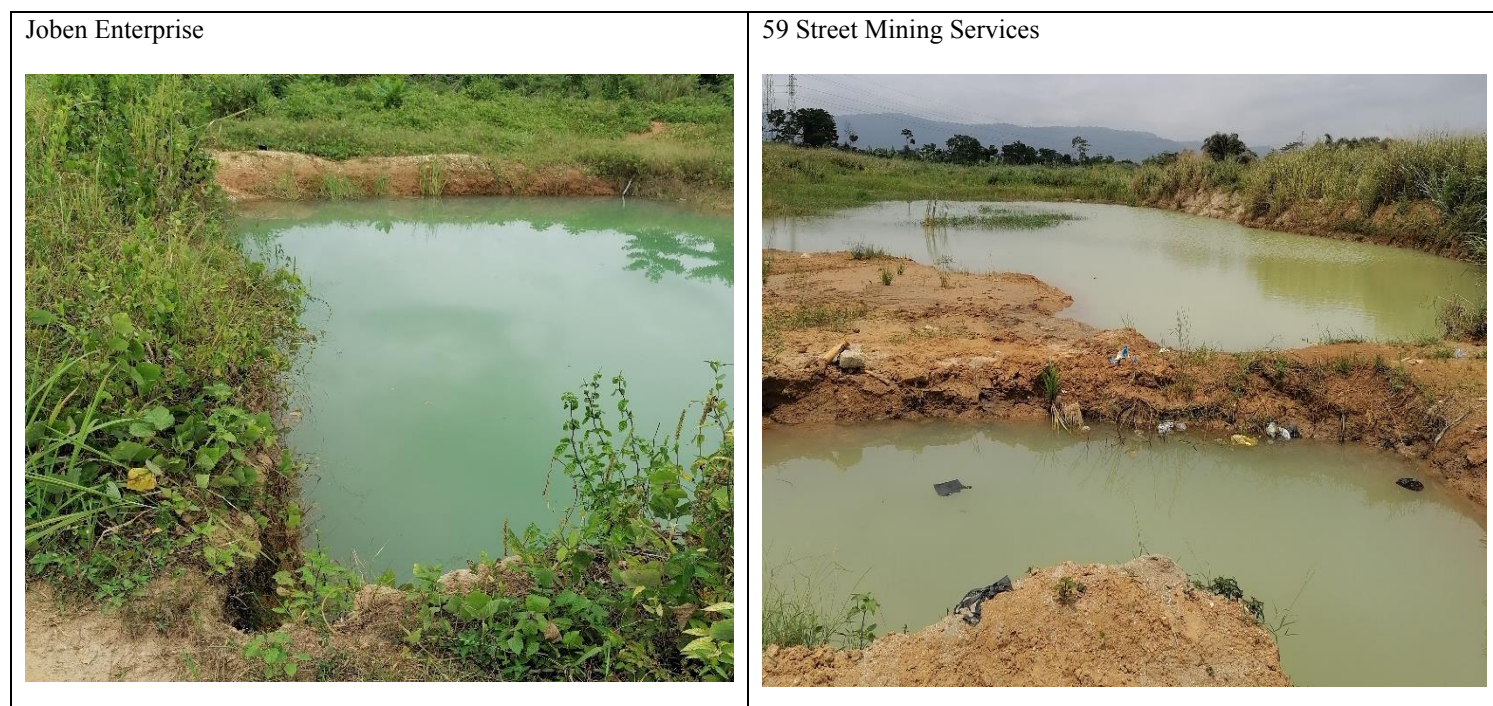
94. We found during the inspections that SSM companies whose licenses had expired from 2018 to July 2020 had from two to seven abandoned pits filled with water. For instance, Faithful Mining Ventures and Harry Mining Enterprise had two and six pits while Joben Enterprise and 59 Street Mining Services had seven and six pits respectively. Each of these pits measured about half of a standard football pitch and were closer to farmlands. Our analysis show that monitoring and reporting did not address the problem of reclamation because if SSM had practiced concurrent reclamation, there should have been at most one inactive pit and not two to seven as we saw. See pictures of the pits in some of the concessions in Picture 4.

Picture 4: Examples of abandoned pits on concessions

100. We recommended that the:

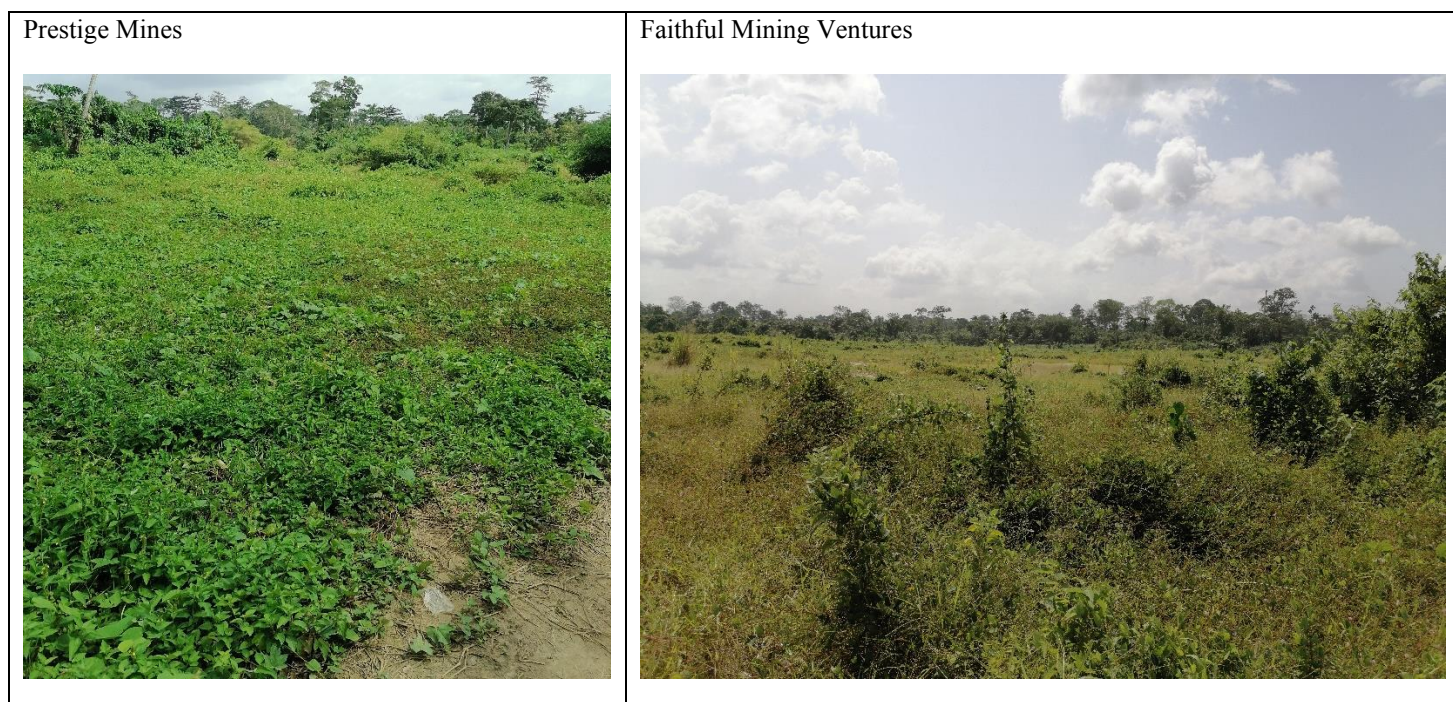
96. Other concessions such as Prestige Mines, Faithful Mining Ventures and Pofco Mining Enterprise had the backfilled portions covered with natural vegetation instead of planting of economic trees as required by permit conditions. See Picture 5.

Picture 5: Examples of backfilled portions covered with natural vegetation

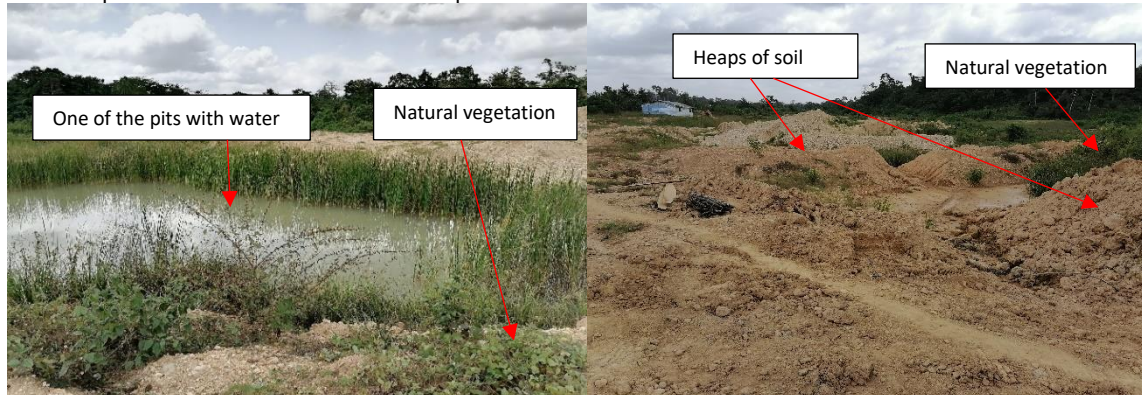
112. We observed during the inspections that the concessions MC provided as reclaimed (refer Table 7), had several uncovered pits filled with water, unlevelled surfaces and growth of natural vegetation. Also, where crops such as cassava, palm oil and coconut had been planted, the plants had not been natured as shown in Figure 2. These observations were contrary to the prescribed reclamation indicators²⁰ in the various license and permit conditions.

Pofco Mining Enterprise: Portions of the concession had been backfilled and taken over by natural vegetation. There were two pits filled with water and several heaps of soil scattered around

115. We recommended that the:

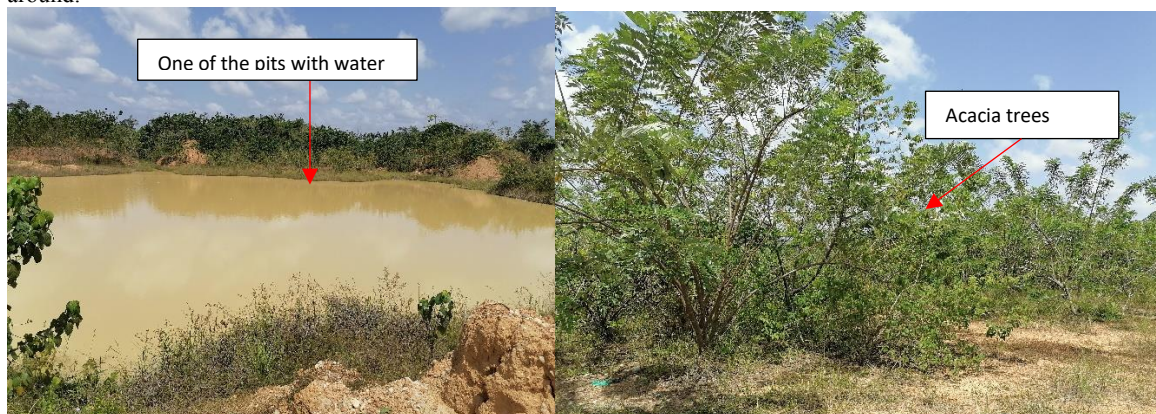
Harry Mining Enterprise: About half of the concession had acacia trees planted. The other half had six pits filled with water and each measured about a quarter of standard football field. The portions with the pits had several heaps of sand around.

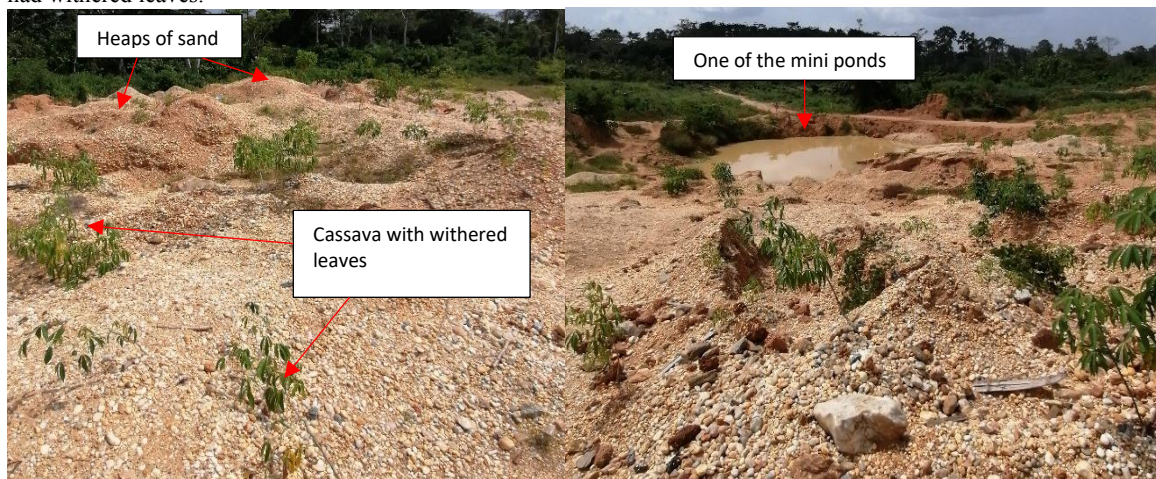
Baymei Mining: Most of the areas have been backfilled but had undulating surface and scattered mini ponds. Had several heaps of soil scattered all over with one pit of about a quarter of a standard football field left uncovered. Planted cassava had withered leaves.

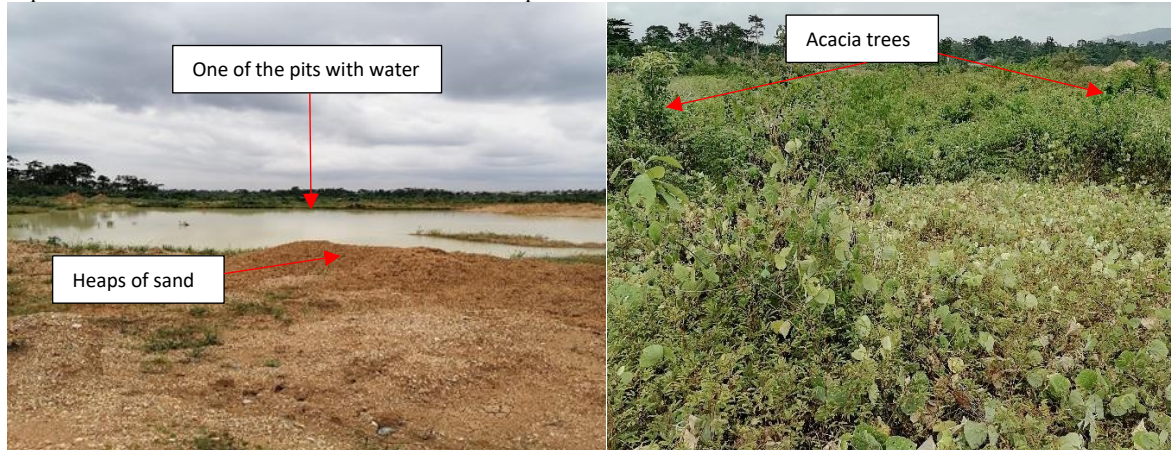
Joben Enterprise: Portions had acacia trees planted and other parts had four pits filled with water. Each measured about a quarter of a football field and there were several heaps of soil scattered around

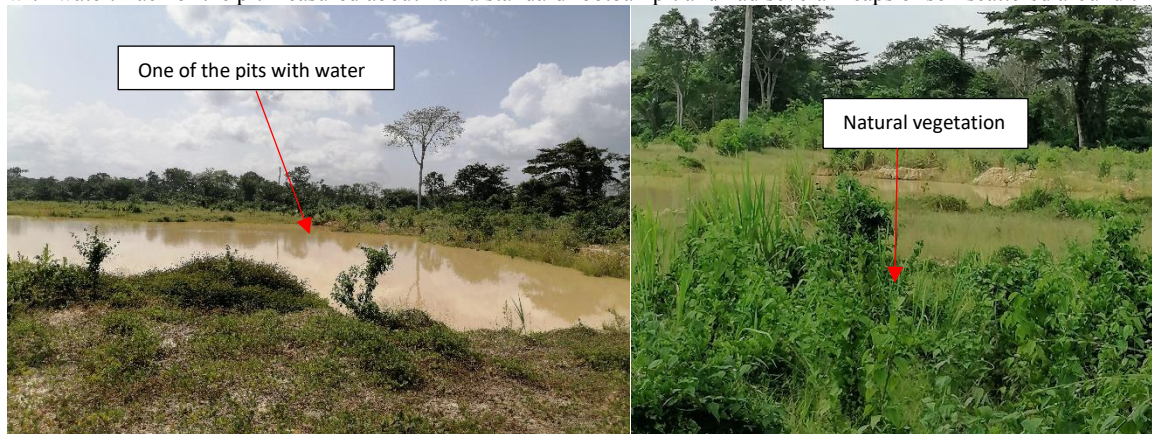
Faithful Mining Ventures: Portions have been backfilled and covered by natural vegetation. There were two pits filled with water. Each of the pit measured about half a standard football pit and had several heaps of soil scattered around them
